CORROSION BEHAVIOR OF ALUMINUM ALLOYS INTENDED FOR  
SACRIFICIAL ANODE APPLICATION IN SEAWATER

J. Perkins, J. R. Cummings,  
R. A. Reinhardt, and K. J. Graham

March 1978

Technical Report No. 6  
To the Office of Naval Research  
Contract No. N00014-78-WR-80105  
36-120

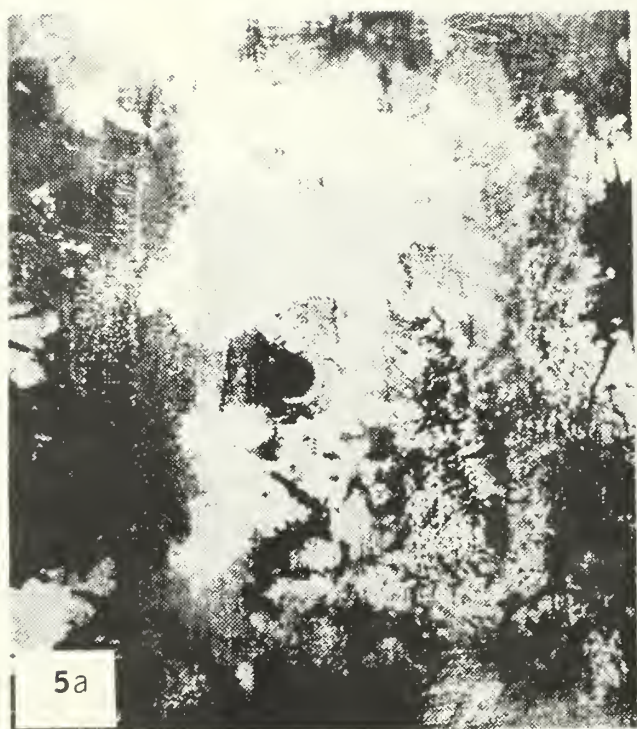
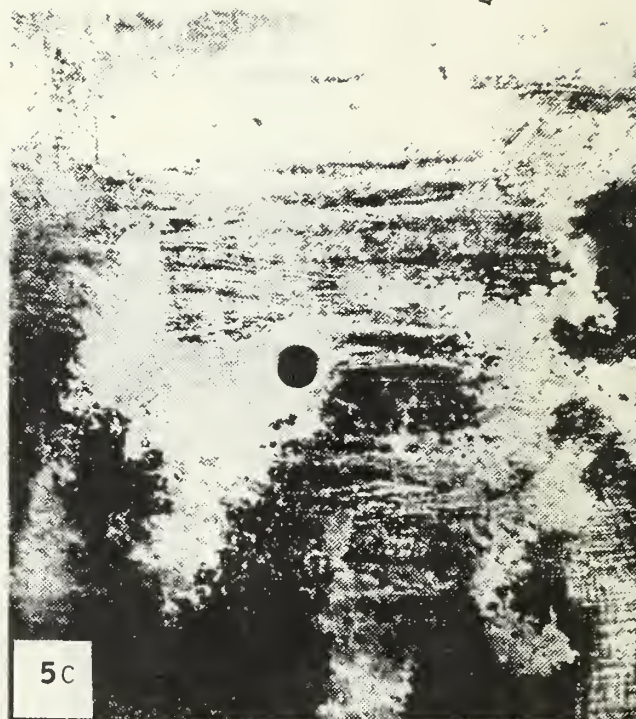
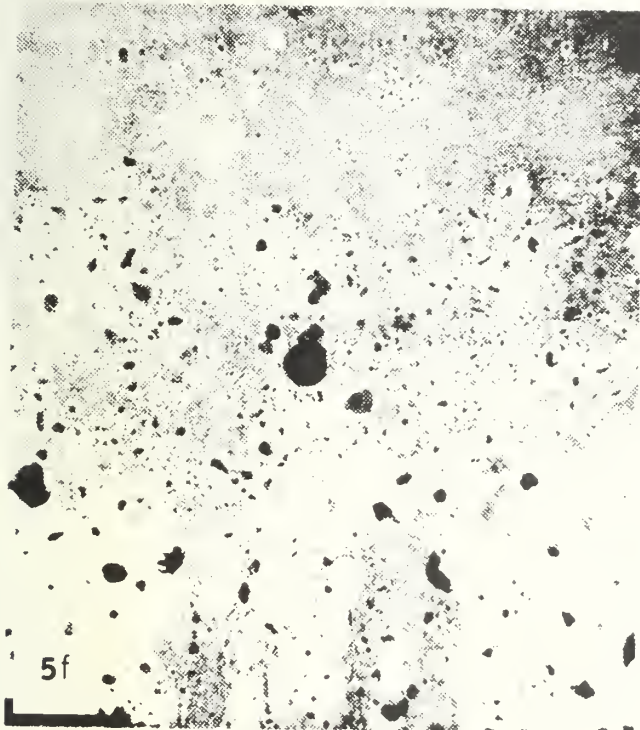
Figure 5: Photographs of HY-80 steel cathodes (8.25 cm x 8.25 cm x 0.32 cm) after 14-days coupling to anodes (area ratio 27:1) in synthetic seawater; the associated anodes were: (a) MIL-SPEC Zinc (b) Galvalum I, (c) Galvalum II, (d) Galvalum III, (e) Reynode II, (f) KA-90, (g) KA-95.

The steel cathodes which are galvanically connected to the anodes became covered with calcareous deposits, and a large amount of flocculent precipitate forms and settles out in the seawater, collecting in the bottom of the cells. Figure 5 is a collection of macrophotographs of the various cathodes, with the calcareous deposits remaining on them after some of the loose-adhering deposits were removed for x-ray diffraction analysis. Cathodes galvanically coupled to alloys R-II and K-90 had more deposits on them than cathodes coupled to the other aluminum alloy anodes. It is well known that seawater, containing predominately sodium chloride, also contains significant amounts of bicarbonates and sulphates, and that these compounds are important in the corrosion process because they act as cathodic inhibitors, (42-44). Under quiescent conditions, as in the present galvanic couple tests, calcium carbonate and other compounds may be precipitated at the cathodic areas; and if the deposits adhere to the cathodic surfaces,

the cathodic process will be stifled. The calcareous deposits effectively reduce the area of the cathode and therefore reduce the anodic current output required for adequate cathodic protection. This factor contributes to the reduction in galvanic current output with time, observed for all the aluminum anode alloys tested. This may be particularly important in the case of the alloy anodes which do not become covered with corrosion product, i.e., alloys G-I, G-III, R-II, and K-90.

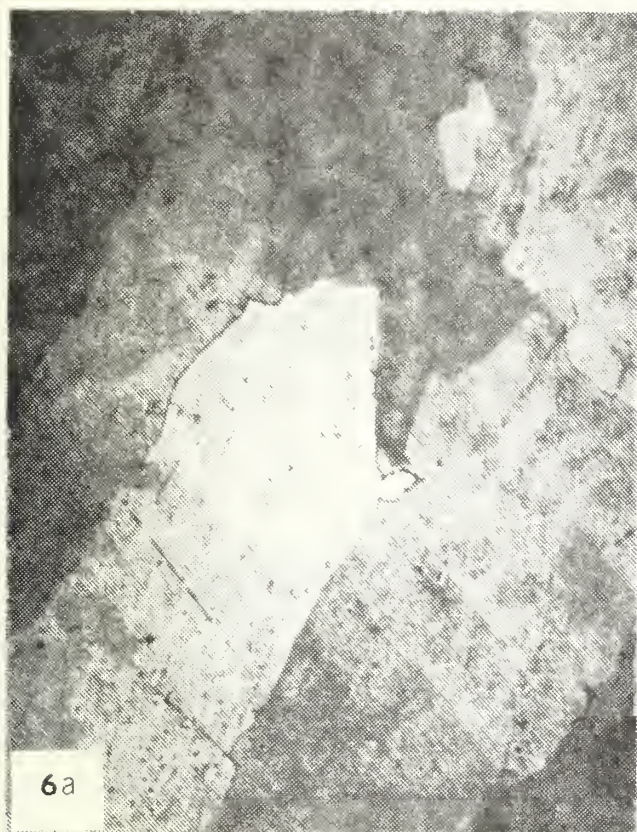
Figure 6. Base-metal microstructures of three aluminum sacrificial anode alloys. (a) Galvalum I, (b) Reynode II, (c) KA-90. Specimens etched with 0.5% hydrofluoric acid. All magnifications 100X.

contrast in behavior between two compositionally similar commercial anode alloys serves to point out that factors other than alloy composition can be of great importance in aluminum sacrificial anode alloys, as demonstrated in this case when comparing the macroscopic corrosion patterns. The base metal microstructures of the G-I and R-II alloys are shown in Figure 6.

The base metal microstructure of alloy G-I is shown in Figure 6a. On the dissolution surfaces there is very little evidence of localized attack that might be associated with this microstructure. The microstructure reveals no second phases or compositional segregation. Figure 6a shows the large grain structure found in the center of the chill-cast "pencil" ingots which were machined to make the test specimens; the outer regions of the mechanical coupons did have somewhat smaller grains; this is evident in some SEM photographs (e.g., Figures 11a and 11d). The center grains of the chill-cast pencils are larger than 1.2 mm, while some grains on the edges of the immersion specimens are on the order of 0.2 mm in diameter.

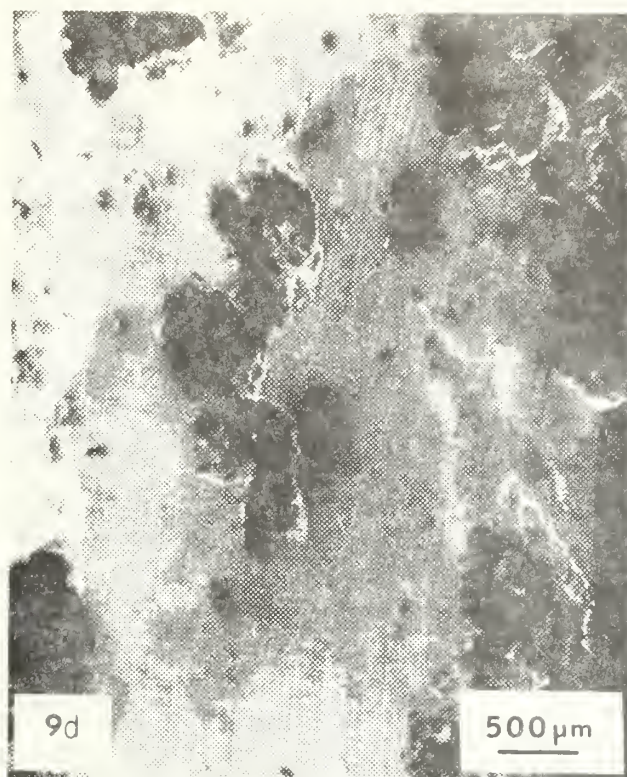
Figure 10: Low-magnification scanning electron micrographs of KA-90 anode coupons after various times coupled to HY-80 steel (area ratio 1:27) in synthetic seawater. (a) 0.5 hrs., 60X, distribution of initial dissolution sites on broad face of specimen, (b) 1.0 hr., 20X, (c) 12 hrs., 20X, (d) 24 hrs., 20X, (e) 48 hrs., 60X, note accumulation of corrosion product near dissolution sites.

At relatively low magnifications (20X to 100X), Figures 8, 9, and 10 illustrate the distribution and progress of dissolution attack on the surfaces of alloys G-I, R-II, and K-90, respectively, after fifteen-minute exposures in (area ratio 27:1) couples with HY-80 steel. Figure 8 shows that alloy G-I exhibits initial dissolution localized along specimen edges, as noted earlier. On the other hand, the local dissolution of alloy R-II begins at an array of sites on the broad surface faces (Figure 9). Alloy K-90 (aluminum-tin-zinc) demonstrates much more profuse pit formation over the entire specimen surface, as illustrated by Figure 10 which shows numerous pits on the order of 30  $\mu\text{m}$  in diameter.

As previously noted, alloy K-90 anode specimens exhibit rapid and profuse pit formation of a more classical type over the entire surface (Figure 8c). The initial pits on alloy K-90, such as seen in Figure 10, are approximately 25-30  $\mu\text{m}$  in diameter after fifteen minutes of galvanic action. As the immersion time increases, pitting action continues, and more pits are generated. This nucleation of more pits is in contrast to the tendency of the two other alloys studied, which are mercury-bearing. Research by Pryor, Keir, and co-workers (7,47) indicated that tin will reduce the corrosion resistance of an aluminum oxide ( $\gamma\text{-Al}_2\text{O}_3$ ) film if the tin is evenly dispersed in the aluminum substrate, as it apparently is in the heat treated alloy K-90. It has been pointed out that only about 0.1% tin can be retained in a metastable solid solution but that homogenized aluminum-tin alloys containing greater than 0.1% tin will still corrode quite uniformly when coupled to steel and in a sodium chloride solution (7). Alloy K-90 nominally contains 0.12 - 0.20% tin, and does corrode "evenly", i.e., shows pitting attack that is uniformly distributed over its surface.
